Fractures of beam-to-column web moment connections, March 1979

FRACTURES OF BEAM-TO-COLUMN WEB
MOMENT CONNECTIONS

March 1979

Supplemental tests and analyses were made to determine the cause of fractures in two beam-to-column web moment connections. Fractures had occurred in tension flange connection plates during static monotonic bending tests of subassemblages containing the connections.

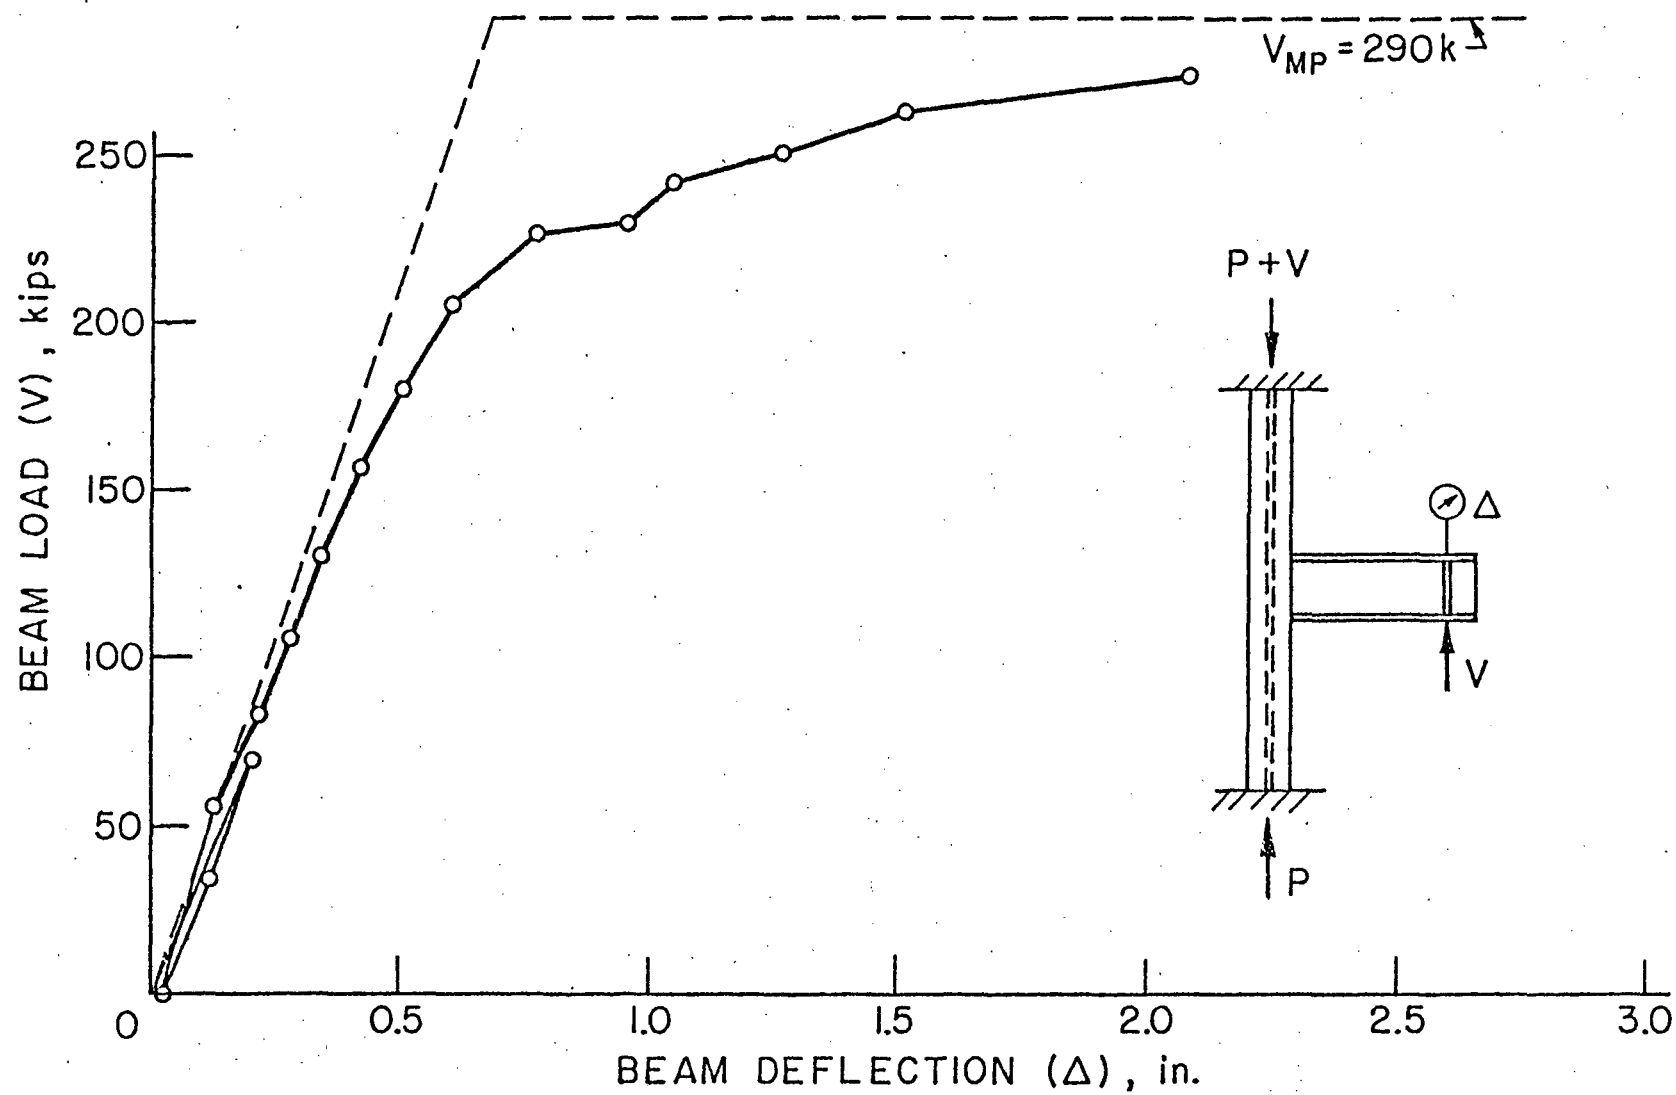
Fig. 2 Load-Deflection Curve of Test 14-1

The load-deflection curve of this specimen is given in Fig. 5. The initial slope of the experimental curve shows fair agreement with the slope of an idealized theoretical curve considering linear effects of bending, shear, and axial deformation.
